INVESTIGATION OF THE STRESS CORROSION CRACKING
SUSCEPTIBILITY OF ANNEALED AND HEAT TREATED
ALLOY 625 CASTINGS AND FORGINGS IN SEA WATER

NAVAL ENGINEER
and
MASTER OF SCIENCE IN MATERIALS ENGINEERING

at the
MASSACHUSETTS INSTITUTE OF TECHNOLOGY
June, 1987

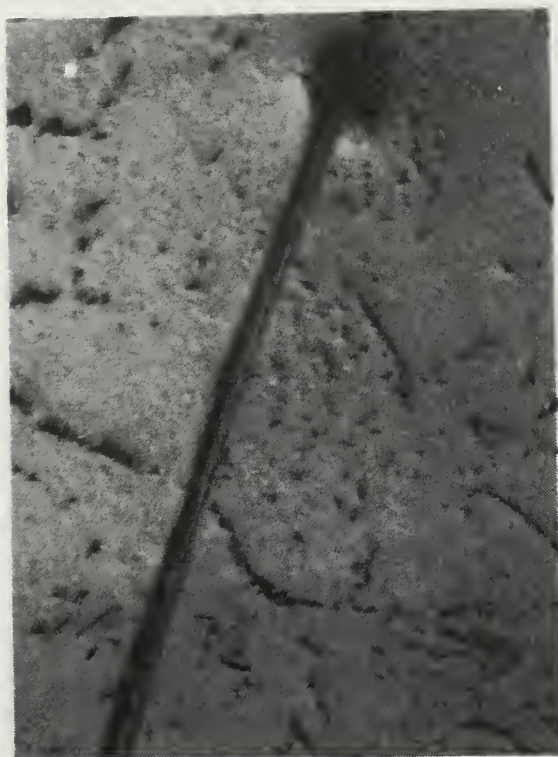
Figure 7 Photomicrographs of "Cast/Heat Treated" Alloy 625

Top Left: 100X
Bottom Left: 50X

Top Right: 1000X
Bottom Right: 1000X

Heat treating the cast material in Figure 7 caused what appears to be globular or blocky $M_{23}C_6$ carbides on the grain boundaries. The bottom photomicrographs show dislocation slip bands throughout the matrix and heavy growth along the grain boundaries.

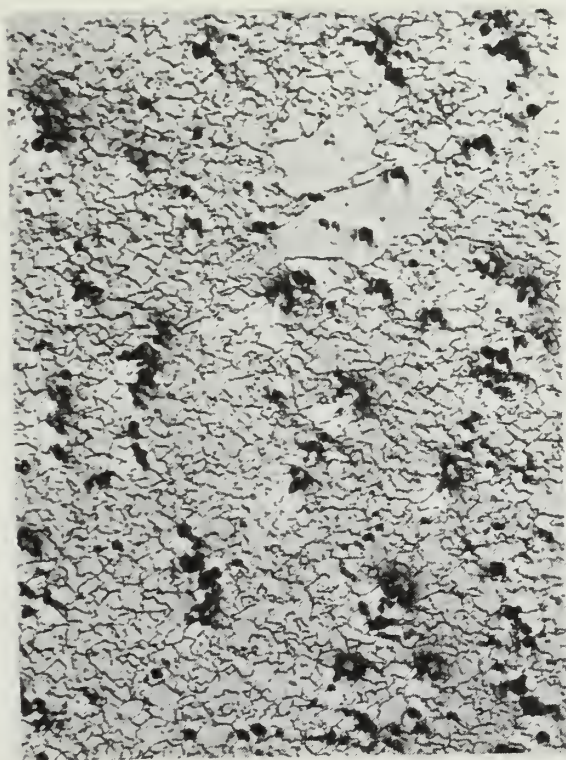
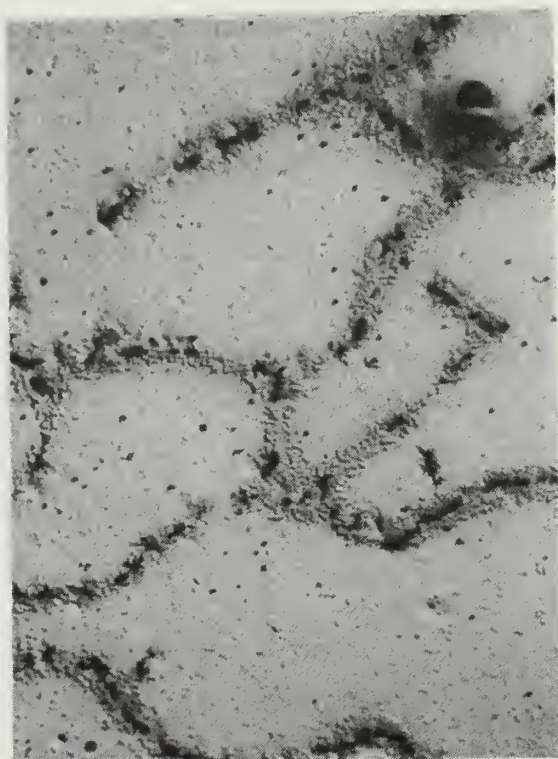
Figure 8 Photomicrographs of "Forged/Annealed" Alloy 625

Top Left: 100X
Bottom Left: 50X

Top Right: 1000X
Bottom Right: 1000X

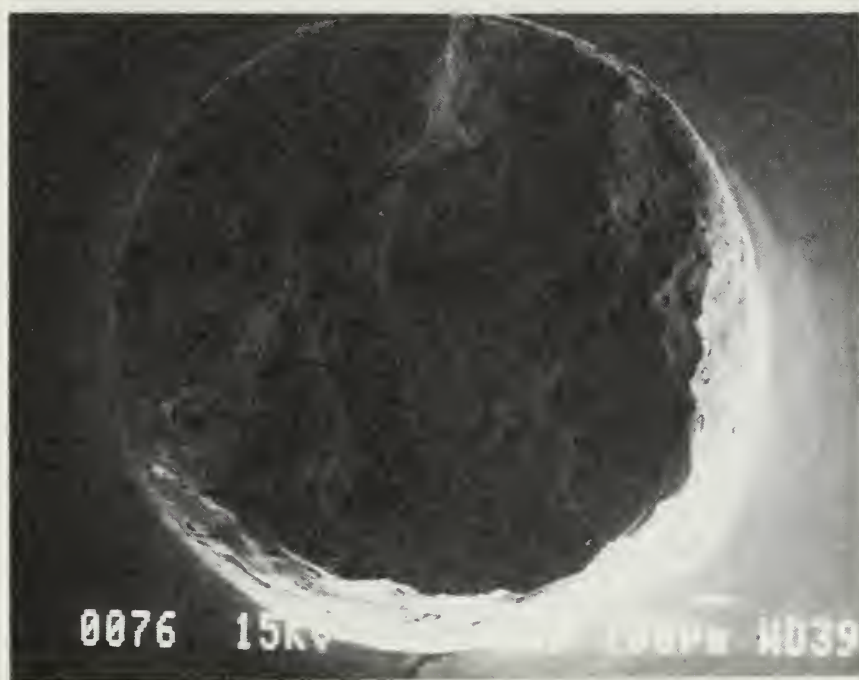
Figure 32 Photomicrographs of "Forged/Annealed" Alloy 625
Fracture Surface for Air Test Condition
Specimen 76
